NASA Technical Paper 2884

December 1988

Cyclic Loads Tests of Carbon Involute Solid Rocket Motor Outer Boot Ring Segments

Rafiq Ahmed George C. Marshall Space Flight Center Marshall Space Flight Center, Alabama

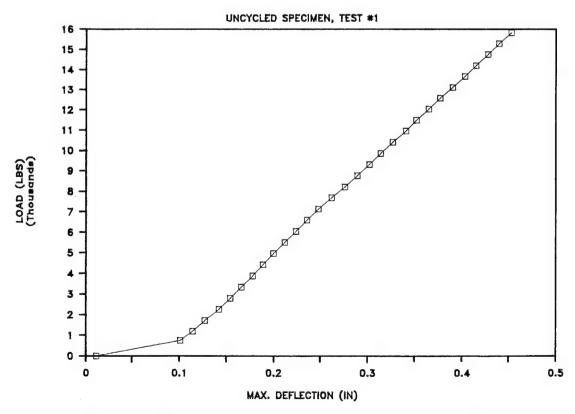
Figure 5. OBR cyclic loads test, uncycled specimen, Test No. 1.

It is important to note that two anomalies occurred in these tests. First, Test No. 1 was loaded to 16,000 lb and then unloaded when test personnel realized (from the low strain readings) that the specimen would not fail at the 20,000-lb capacity of the original load cell. The load cell was changed to

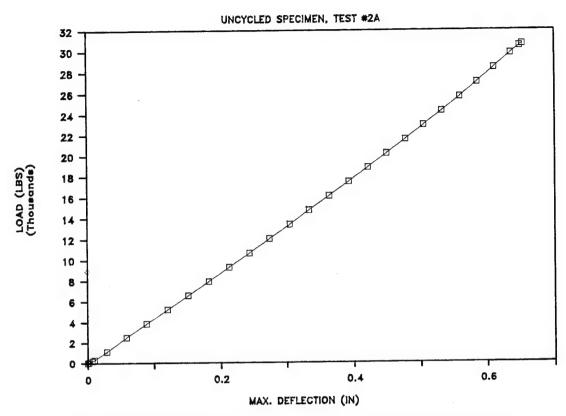
Figure 8. OBR cyclic loads test, uncycled specimen, Test No. 2A.

Typically, most of the load versus deflection and load versus strain curves were linear in the elastic range with a decrease in slope as higher loads were reached. However, an interesting phenomenon occurred in Test No. 2A, where an increase in slope of both the load versus deflection and load versus strain curves was noted as the load approached ultimate. These plots also showed that the specimen stiffness was lower in the linear range for Test No. 2A than for Test No. 2. This was attributed to matrix degradation in the CCP that resulted from the first loading of 34,000 lb (which was at or near imminent failure), while the increase in stiffness at the higher load levels of Test No. 2A was attributed to microcracking of the fibers (this most likely happened in Test No. 2). The fibers sustain most of the load at these higher load levels. It is interesting to note that none of the cyclic loadings produced a similar effect in the material, since they were of insufficient peak load.

The agreement between the elastic moduli of the different samples is quite good; the scatter between the lowest and the highest moduli (not including Test No. 2A) is only 12 percent. As noted previously, Test No. 2A's modulus is low due to degradation of the part from Test No. 2. The increase in Test No. 2A's plastic modulus is clearly seen.

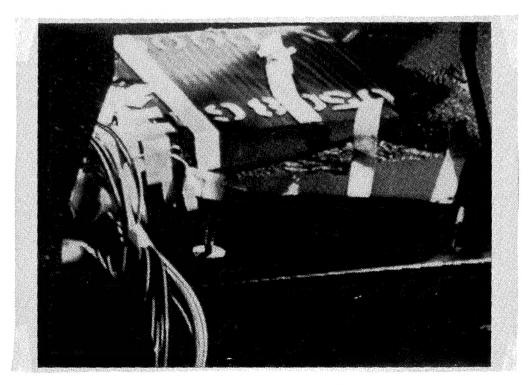
Figure 21. Test setup after failure.

Fiber failures and delaminations were noticed in the failures of all specimens. Fiber breakage occurred primarily on the tension side of each specimen except No. 5, while delaminations occurred mostly on the compression side. This happened because the compressive fiber strength of the material is much greater than the tensile strength; therefore, the compressive-side material tended to peel away during failure.

Specimen Nos. 4, 5, and 6 showed significant secondary cracking through the thickness of the segment, apparently caused by the cycling routine imposed on each. The matrix, but not the fibers, seemed to have been degraded by cycling, thereby facilitating crack propagation. The secondary cracking may also account for the unique tension-side delamination in Specimen No. 5.
